# ANJI YIKE DECORATION MATERIAL TECHNOLOGY CO., LTD

## TEST REPORT

Woven vinyl flooring

191106006SHF-003

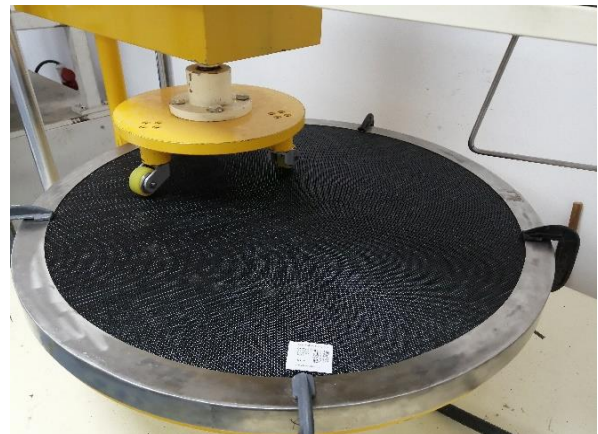
Type of damage	Observation (Yes/No)	Verdict
Loosening, swelling or tearing of the covering	No	Pass
Delamination	No	
Flaking or delamination of foam backin	No	
Loss of cohesion and lor powdering of binder	No	
Any destruction of the material as a whole	No

After 25000r
